4 High Potential Near Miss: Unplanned Handling of Unexploded Ordnance

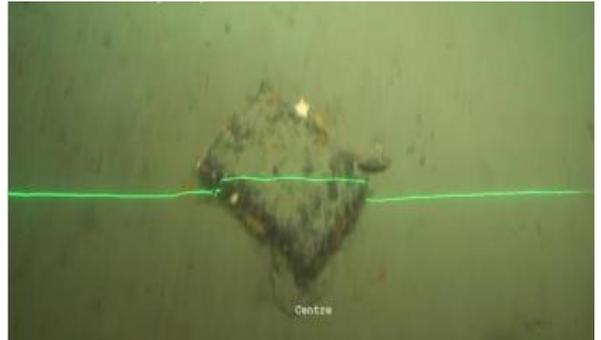
During the initial phases of the operation, several boxes previously classified as concrete debris were investigated and observed to be boxes containing dumped munitions. These boxes were left in place on the seabed. Later in the operation an item recovered, believed to be 'machine parts', was recovered to the vessel deck. The box was handled by vessel crew before they realised it was a WWII munitions box. Expert advice was obtained and the UXO was returned to the seabed.

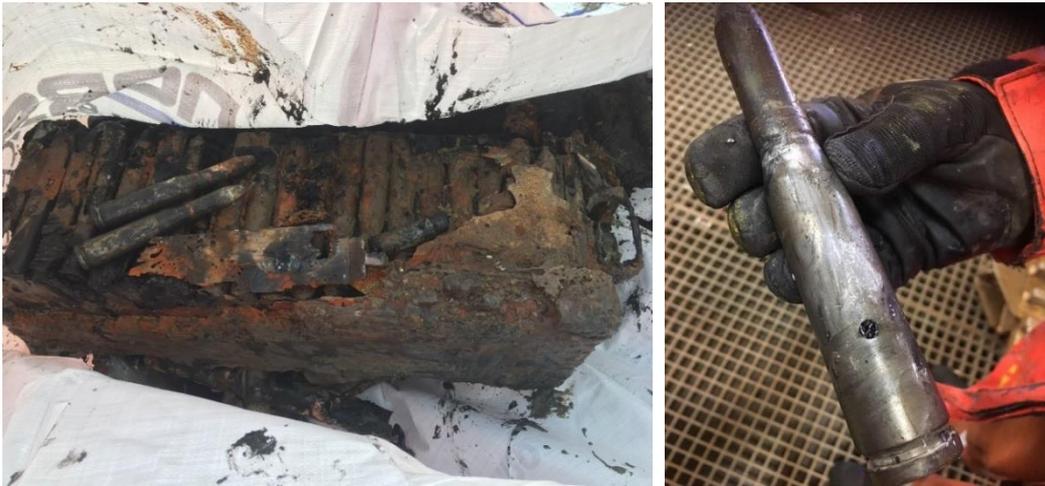
- ◆ An ROV attempted to move 'concrete objects' which disintegrated, and cartridges fell out. A cartridge magazine was picked up by the ROV and a request made for it to be brought to deck. Some cartridges were released, a magazine was released by the ROV and dropped to seabed. No 'all stop' called at this stage;

- ◆ Shift logs identified that the ROV continued to locate and move additional items of potential ammunition into subsea basket and relocated what was thought to be barrels/drums, but what were later identified to be munitions. Operations continued and no 'all stop' called;

- ◆ Personnel handled dangerous items, bringing them to deck, and one person tampered with a piece of ammunition attempting to verify its condition. Personnel raised concern to on-board management;

Items recovered to vessel deck

- ◆ Reinforcement required of stop work authority and MoC, specifically actions towards managers/leaders;
- ◆ Revision required for procedures covering actions to be taken in the event of discovering dangerous items such as UXO;
- ◆ Method of survey to be re-evaluated;
- ◆ Additional training and guidance to teams involved in debris clearance operations.
